**CALSPAN ON-SITE INVESTIGATION OF TWO COMPRESSED NATURAL GAS
(CNG) CYLINDER RUPTURES
CALSPAN CASE NOS. 94-19 AND 94-20**

VEHICLES - TWO 1992 GMC SIERRA 2500 PICKUP TRUCKS

**CALSPAN CASE NO. 94-19 AND CASE NO. 94-20
COMPRESSED NATURAL GAS CYLINDER FAILURES
1992 GMC SIERRA 2500 SERIES PICKUP TRUCKS**

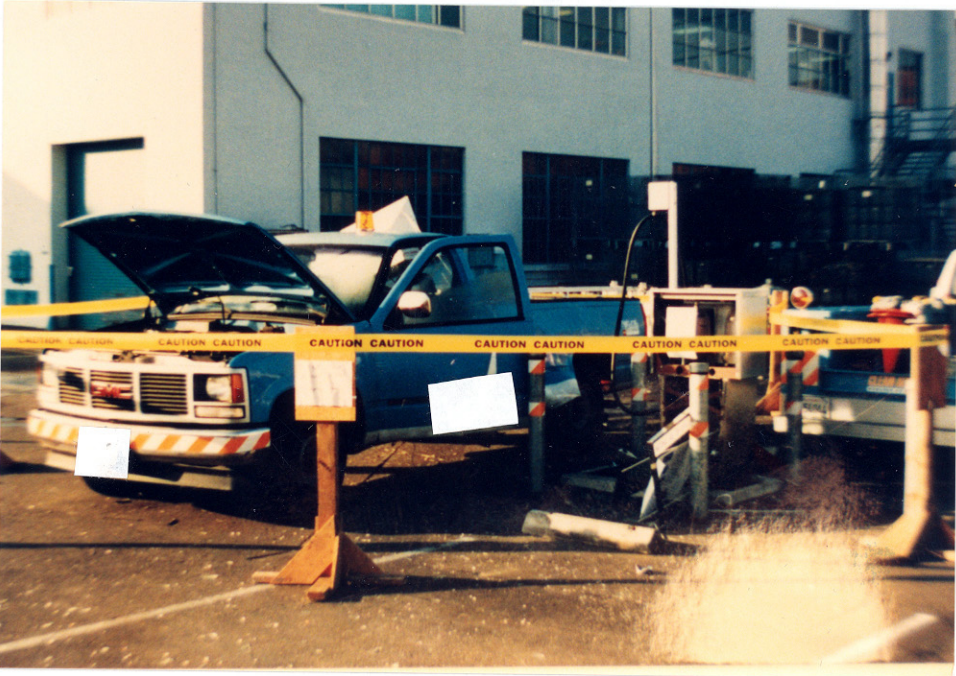
1. Damaged Vehicle and Fuel Pump at the Scene of the Incident

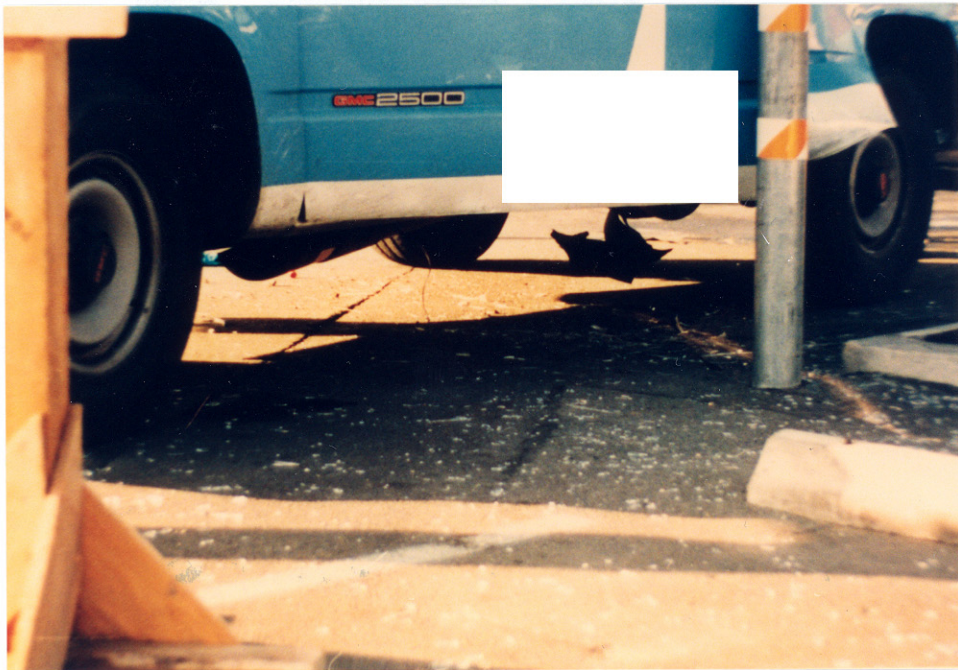
3. View Toward the Left Undercarriage Area of the Pickup Truck

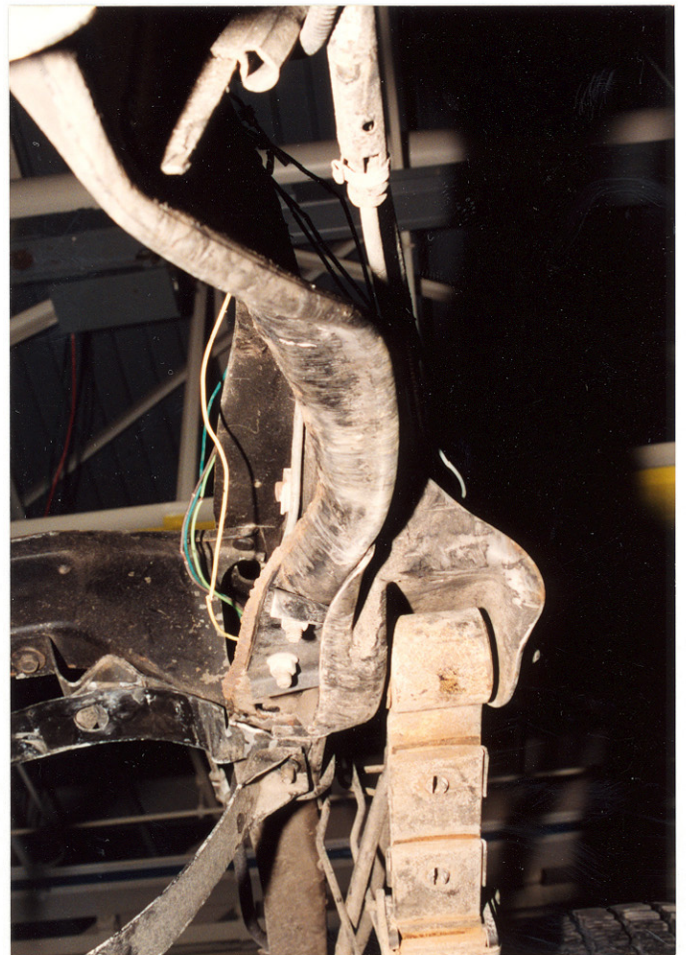
28. View of the left frame rail from underneath showing the lateral outward displacement resulting from the CNG tank failure

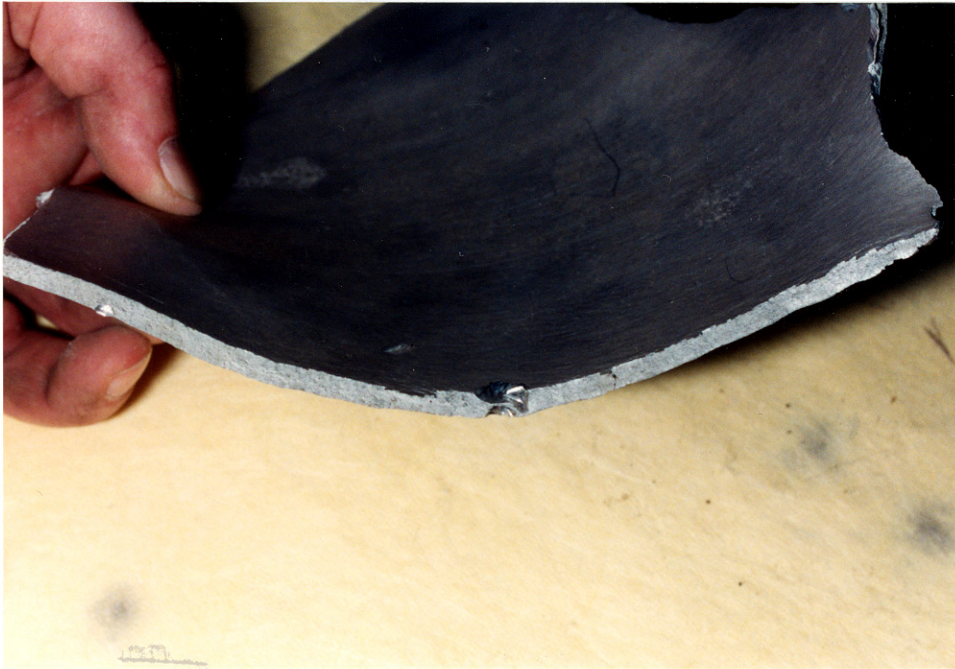
49. Close-up view of the edge of the aluminum tank fragment

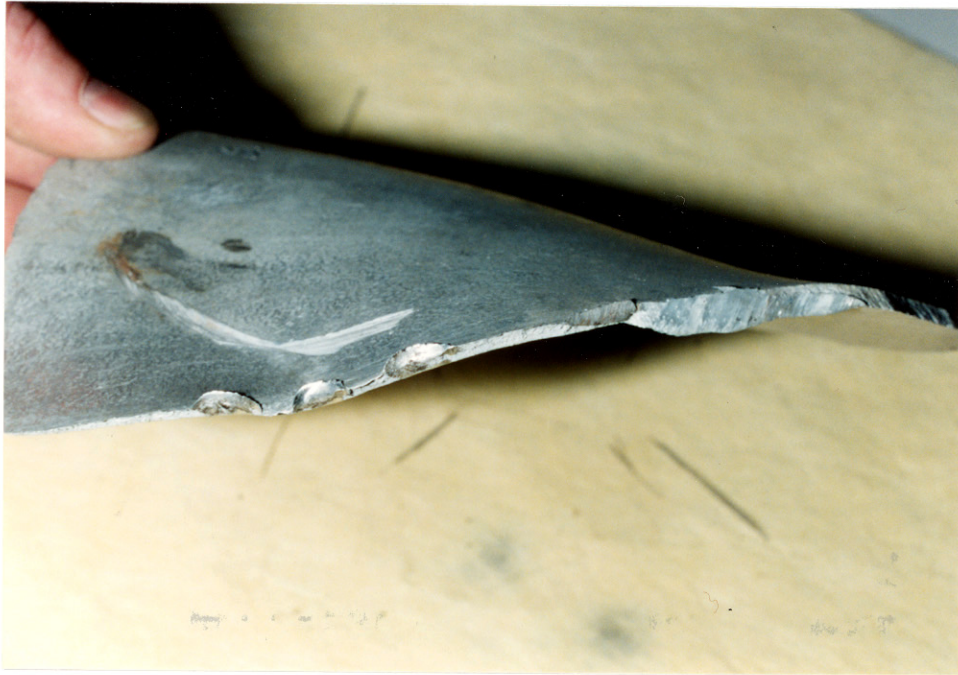
51. Another close-up view of the edge of the aluminum tank fragment

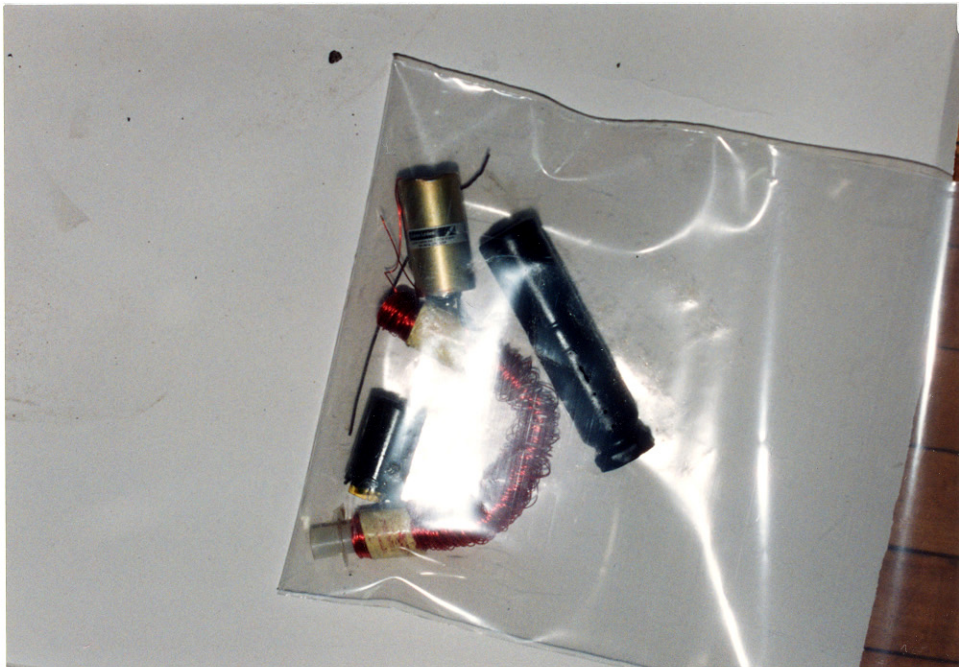
52. View of internal valve components of the failed CNG tank
